Drawing Title EXISTING PHOTOS - BASEMENT		Project Title CORRECT LIFE SAFETY DEFICIENCIES BECKLEY VAMC FINAL SUBMITTAL		Date 09-5-2014	
Approved Project Engineer		Building Number -		Project No. 517-14-106	
		Checked DM		Drawing No. A700	
		Location ----		Dwg. XX Of XX

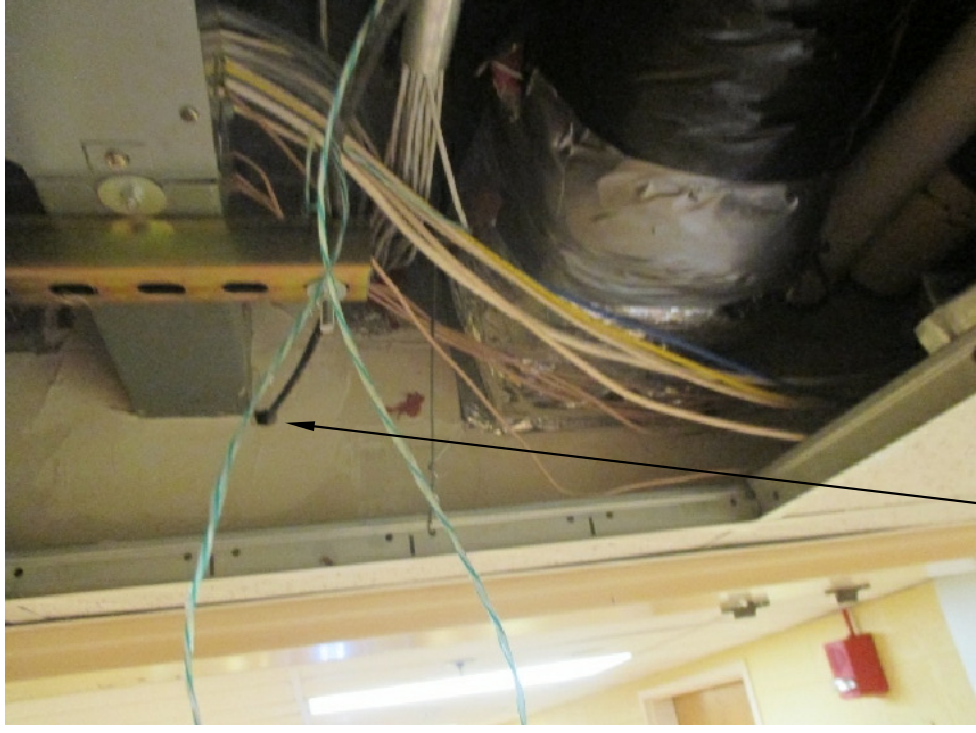
CAJ-J-3283 (CABLES) W-J-A027 (CABLE TRAY)
15 BASEMENT — PENETRATIONS IN TWO-HOUR RATED WALLS — 15
A700 / NTS

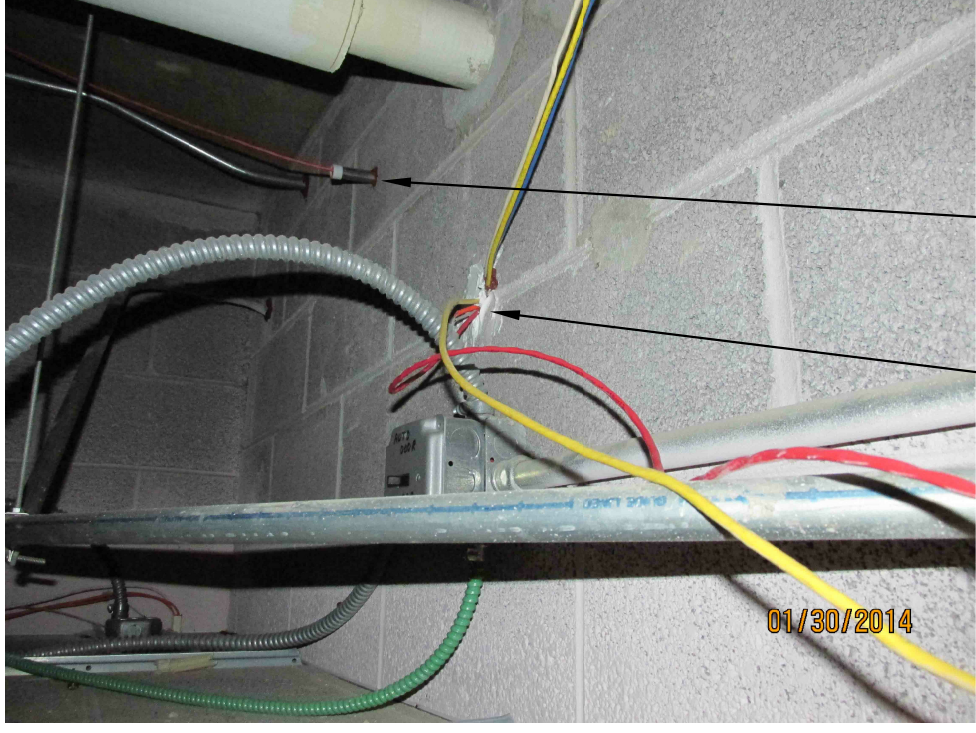
C-A-J-5091 (PIPE) C-A-J-3320 (CABLES)
14 BASEMENT — PENETRATIONS IN TWO-HOUR RATED WALLS — 14
A700 / NTS

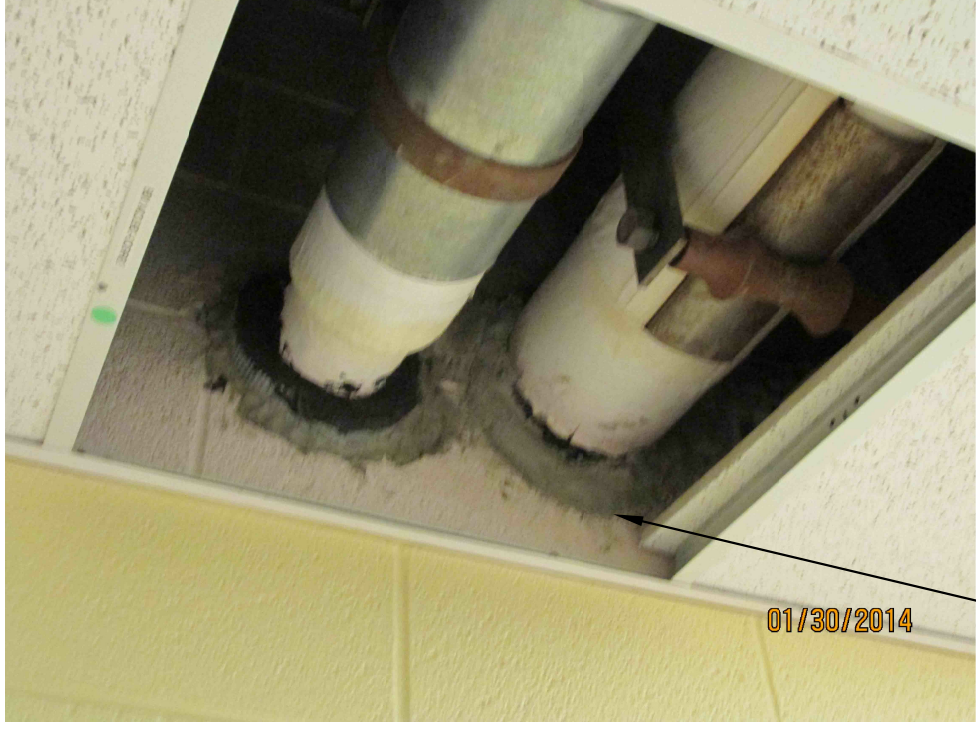
W-L-1128
13 BASEMENT — PENETRATIONS IN TWO-HOUR RATED WALLS — 13
A700 / NTS

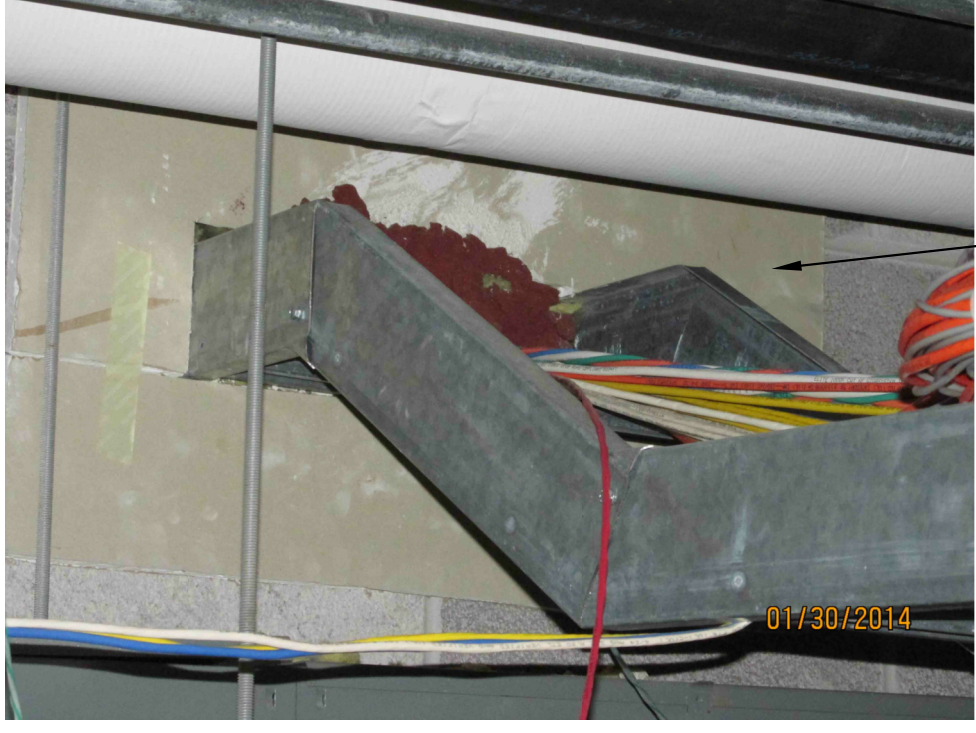
W-J-4027
12 BASEMENT — PENETRATIONS IN TWO-HOUR RATED WALLS — 12
A700 / NTS

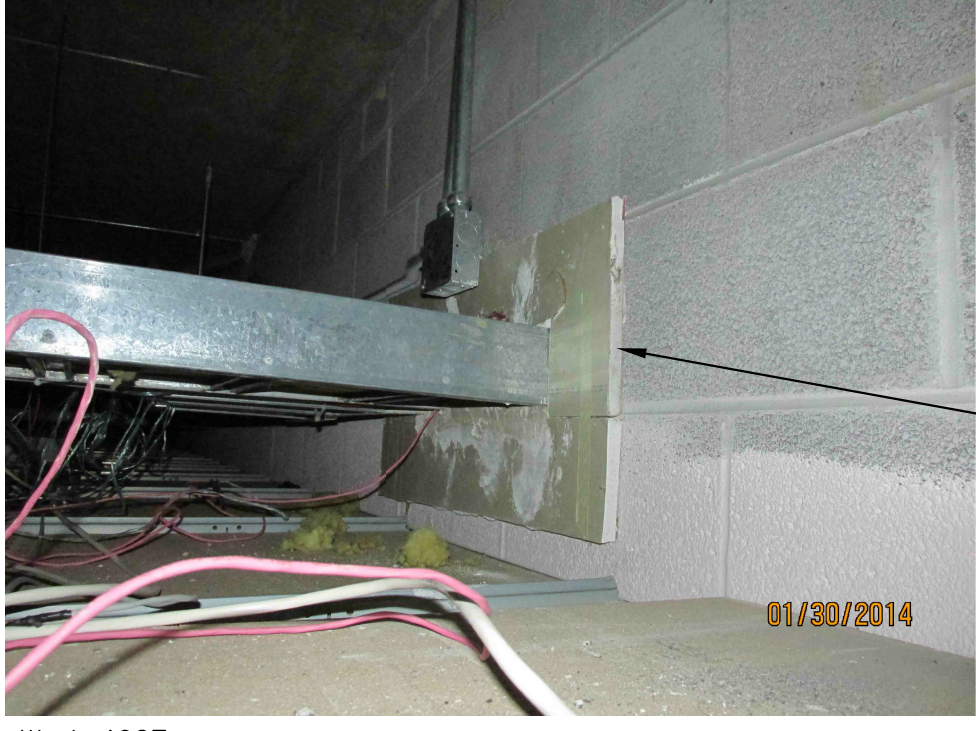
W-J-4027
11 BASEMENT — PENETRATIONS IN TWO-HOUR RATED WALLS — 11
A700 / NTS

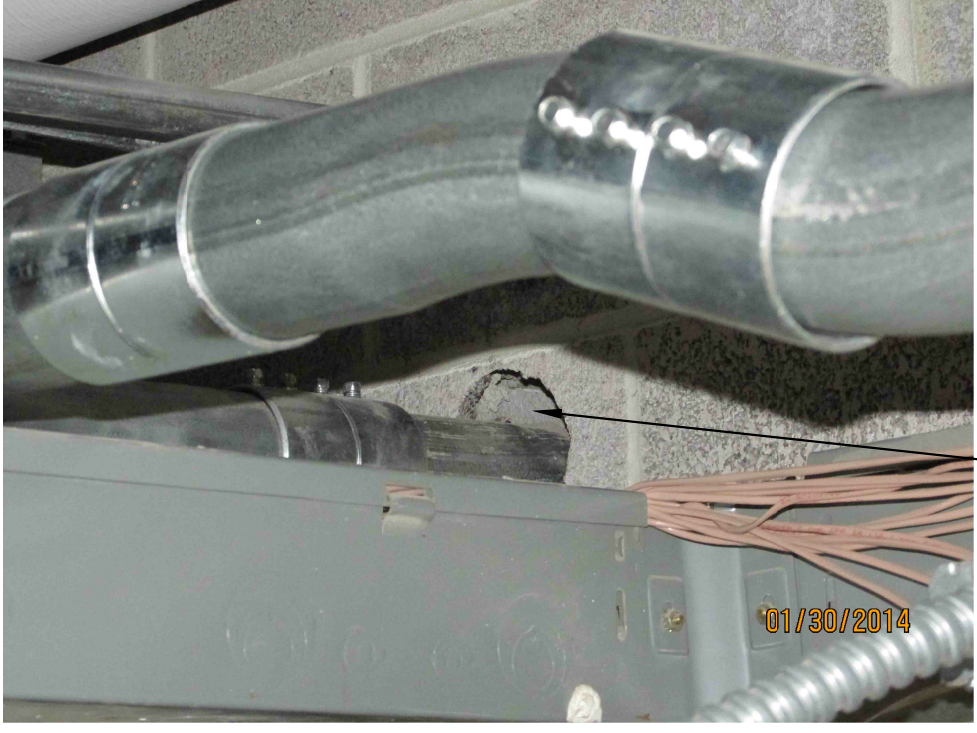
W-L-8035
9 BASEMENT — PENETRATIONS IN TWO-HOUR RATED WALLS — 9
A700 / NTS

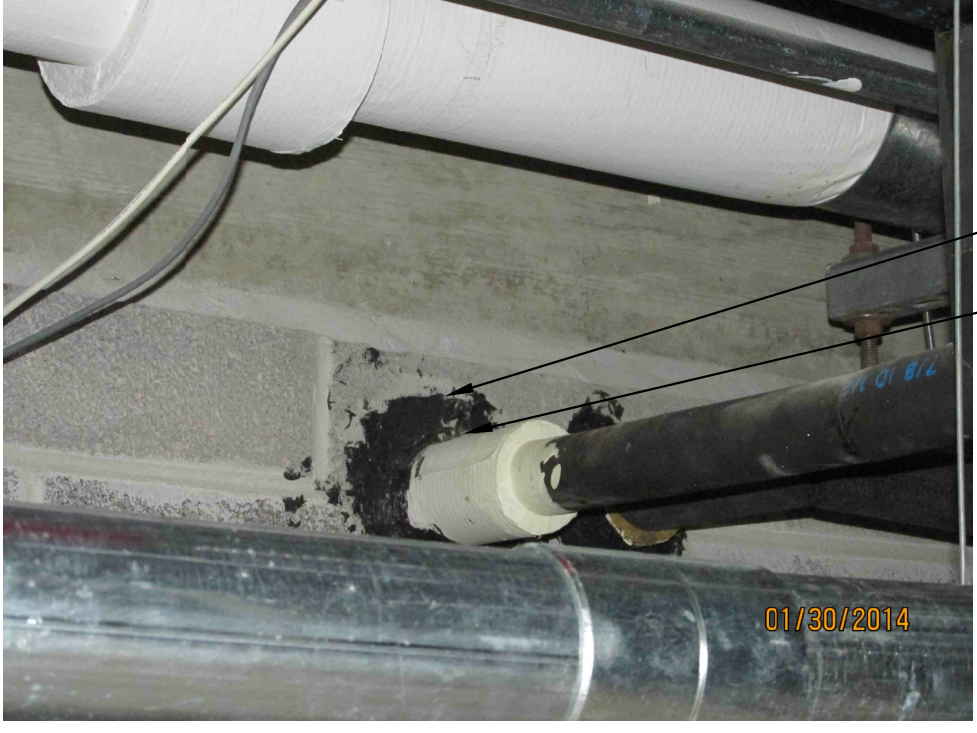
W-L-1128
8 BASEMENT — PENETRATIONS IN TWO-HOUR RATED WALLS — 8
A700 / NTS

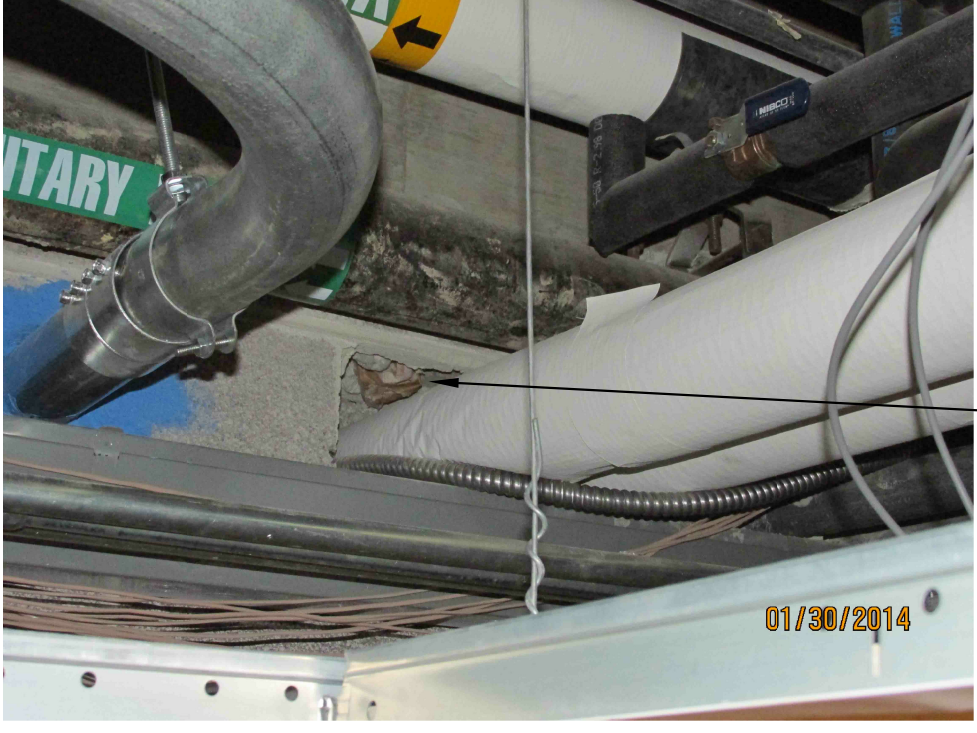
W-L-8035
7 BASEMENT — PENETRATIONS IN TWO-HOUR RATED WALLS — 7
A700 / NTS

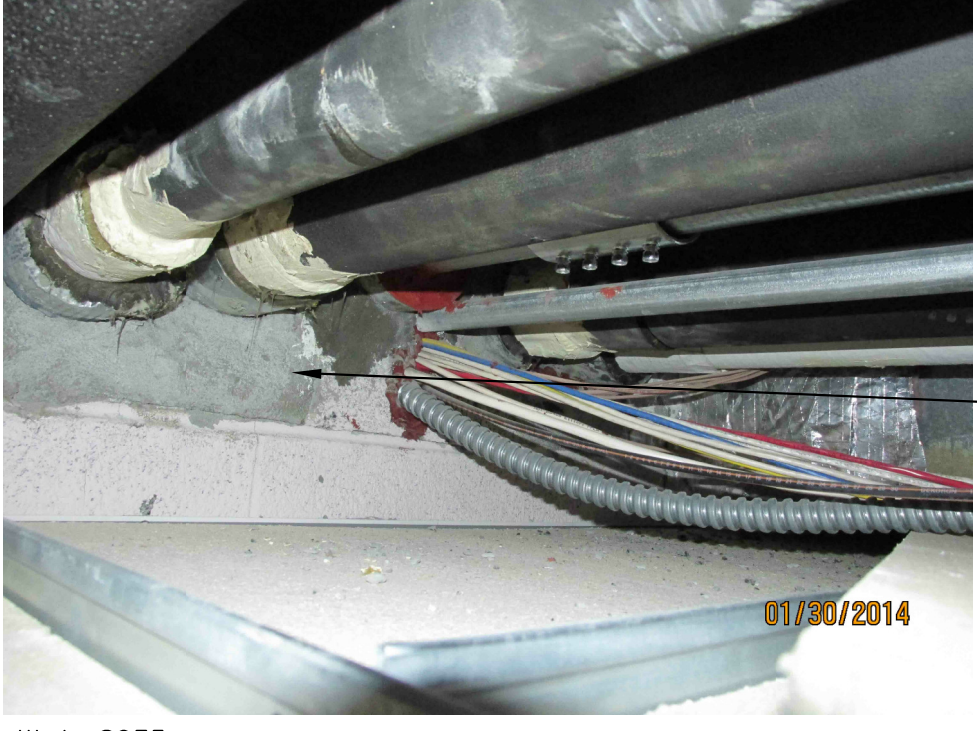
W-L-8035
6 BASEMENT — PENETRATIONS IN TWO-HOUR RATED WALLS — 6
A700 / NTS

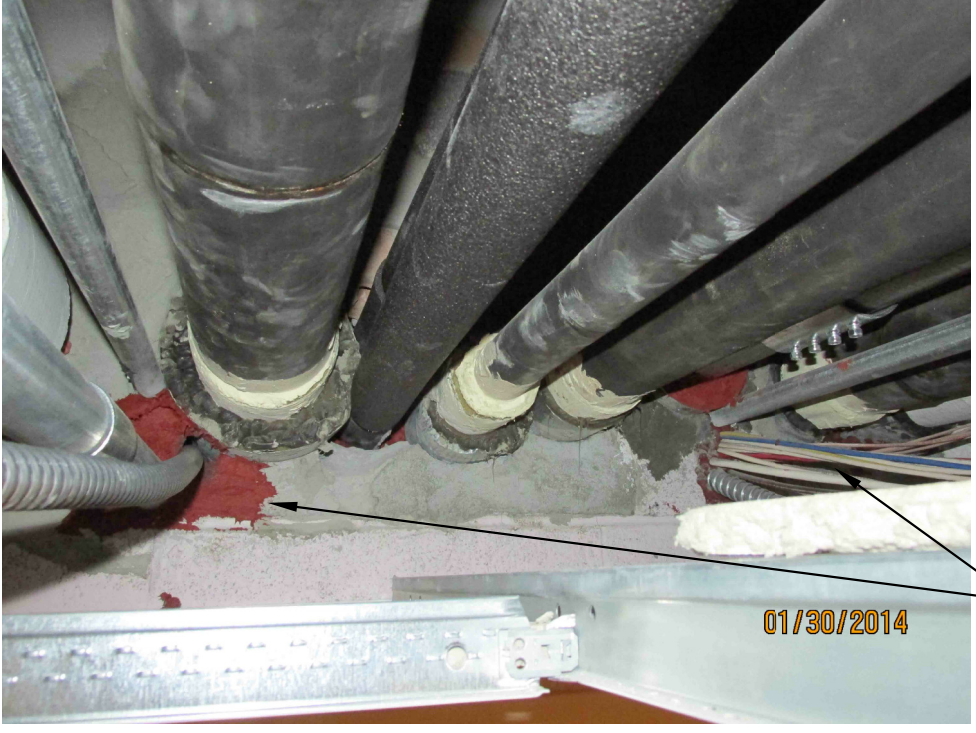
W-J-8035
5 BASEMENT — PENETRATIONS IN TWO-HOUR RATED WALLS — 5
A700 / NTS

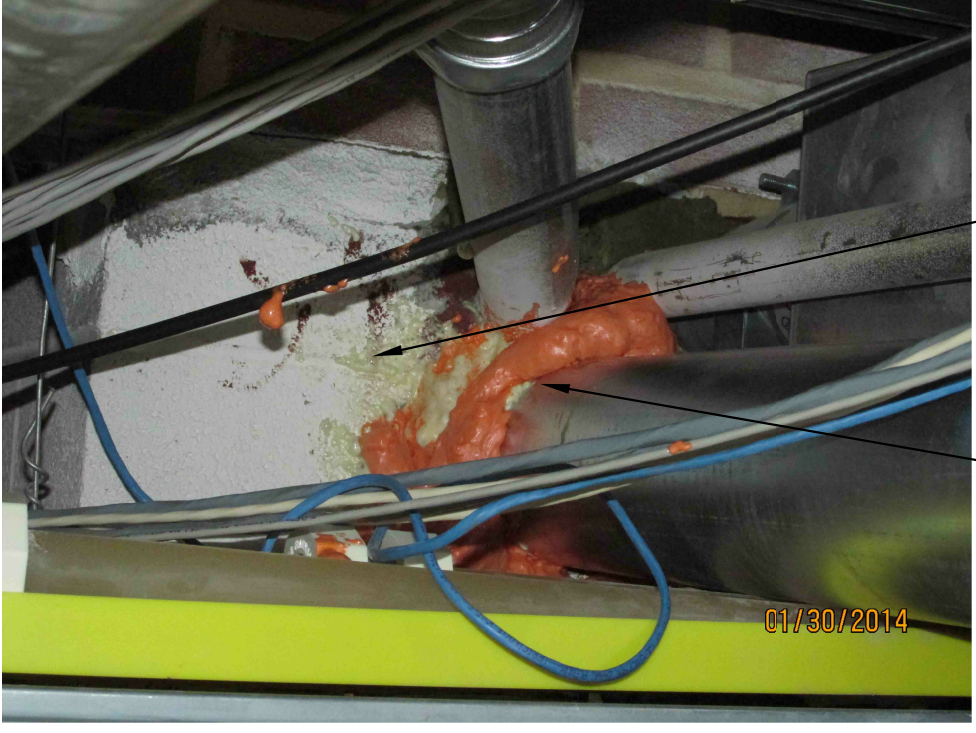
C-A-J-8143
4 BASEMENT — PENETRATIONS IN TWO-HOUR RATED WALLS — 4
A700 / NTS

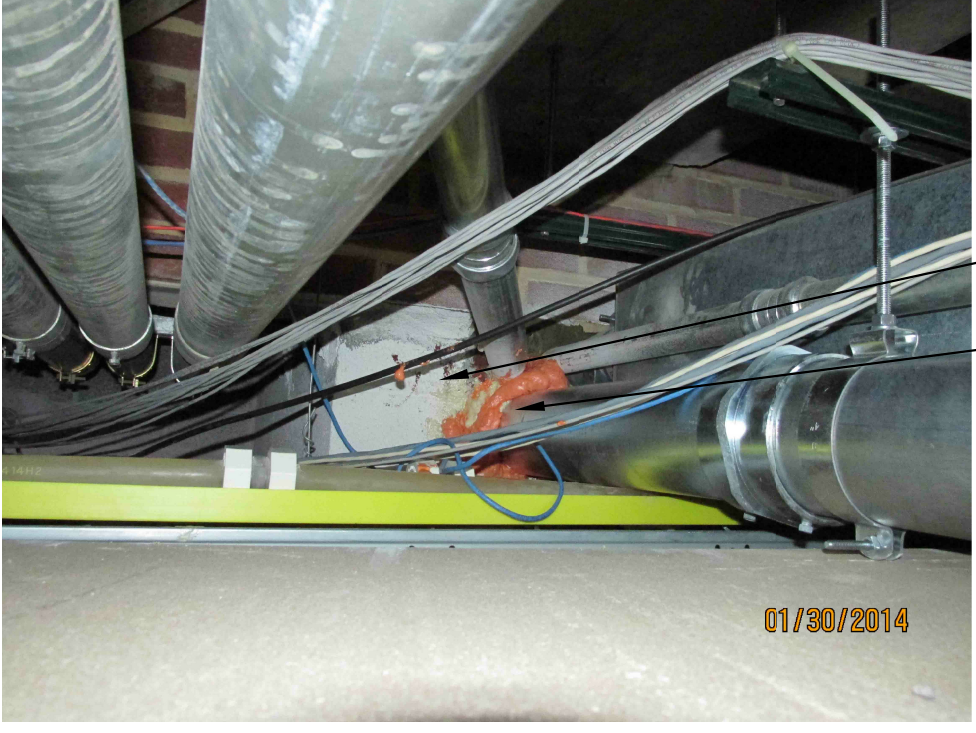
C-A-J-8143
3 BASEMENT — PENETRATIONS IN TWO-HOUR RATED WALLS — 3
A700 / NTS

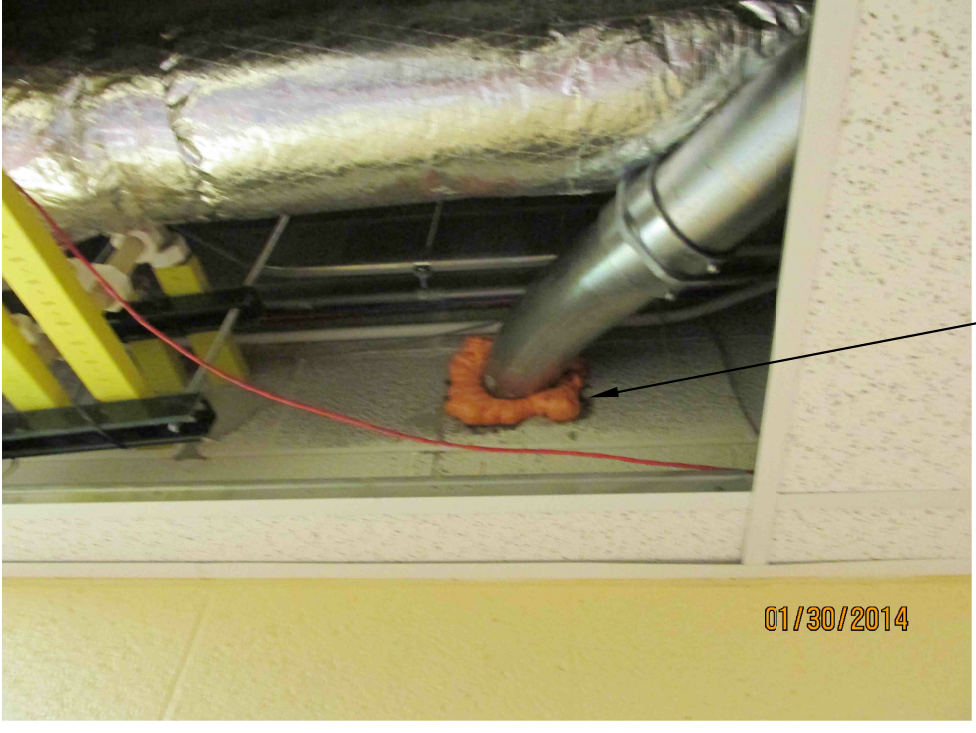
C-A-J-1226
2 BASEMENT — PENETRATIONS IN TWO-HOUR RATED WALLS — 2
A700 / NTS
